On-site Assessment of High Voltage Motors Insulation Operating in Oil Facilities

Abstract. Thirteen motors rated at 13,8 kV and 2500 H. P. of capacity installed and operating in a critical Oil Pumping Plant, were evaluated on-site, to determine the insulation system condition and schedule a maintenance program. This on-site assessment was based on a non-invasive and non standardized ultra-wide band partial discharge technique developed. The results obtained allowed motors insulation system status classification, according to partial discharges measured on ground connection of the main cables of the motor, employing near field sensors. A traditional N-Q- Φ Partial Discharge pattern is obtained to facilitate motor insulation system problems identification. The results of this on-site motor assessment, during normal operation, and its application on maintenance programs are presented and discussed in the paper.

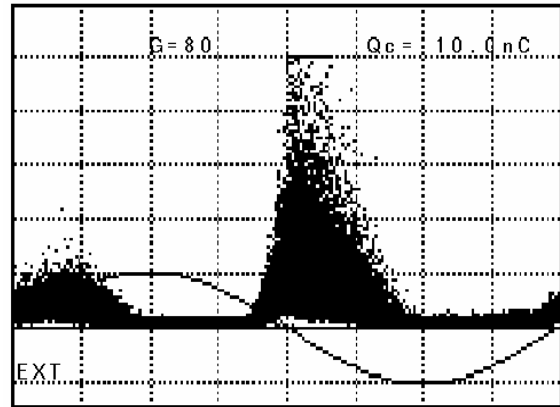
The PD pattern shown in Figure 2, shows the PD activity map obtained in phase 3 of motor M-14. It distinguishes that PD in the negative semi cycle are greater than those of positive in 5:1 relationship. This pattern and the high

level of DP (570 nC) according to [5], is typical of the activity of slot partial discharges (PD between coil surface and stator core laminations). This mechanism of deterioration is the most severe, from the electrical insulation point of view.

Fig. 2. Motor M-14 PD pattern, 570 nC Max.

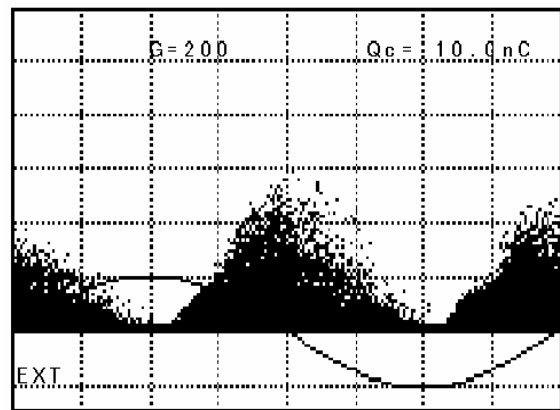
The Figure 3, shows the pattern of the PD activity map obtained in phase 2 of motor M-13. The partial discharges have similar magnitudes in both semi cycles. The pollution deposited in the end windings can be the PD cause; the pollution avoids the correct graduation of electric field. Another cause may be the deterioration or incorrect stress grading coating application.

Fig. 3. Motor M-13 PD pattern 120 nC
