# The Induction Motor as a Mechanical Fault Sensor in Elevator Systems

**Abstract-** An efficient maintenance carried out on a building elevator system can contribute to guarantee a safer people transportation. An elevator failure must be avoided as much as possible, as it may have negative consequences on different levels, as fear, trust lack, people's elevator phobia or even people's life. This paper presents a method that uses the induction motor as a sensor, to diagnose mechanical faults in the worm gear reducer of an elevator system. This study complements another work already done, by the same authors, concerning elevator guides remote monitoring.

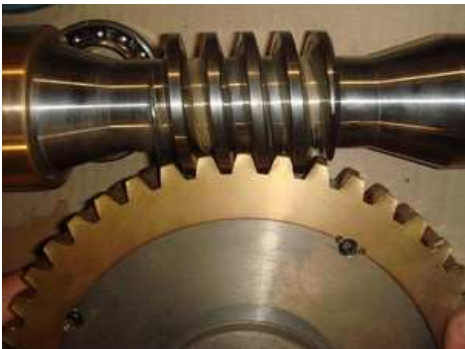
Fig. 2: Worm gears.

The worm, with its continuous helix, forms one continuous tooth, engaging the worm wheel (Fig. 2). The shape of teeth of the worm wheel allows large forces to be transmitted from the worm to the worm wheel. Unlike other gearing systems, in

which the output may drive the input, the worm (the input) always drives the worm wheel and they are self-locking [12].

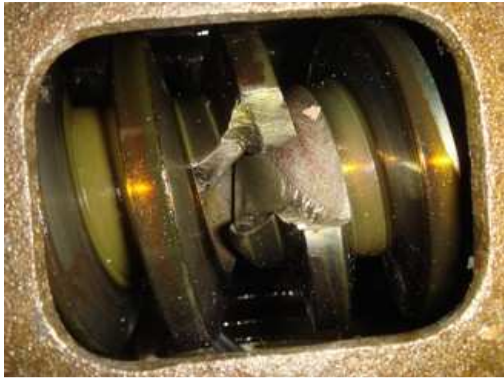
When the above condition is not fulfilled a machine breakdown may occur: the teeth may crack or even the worm may break as shown in the example of Fig. 4.

Fig. 4: Detail of a broken worm.

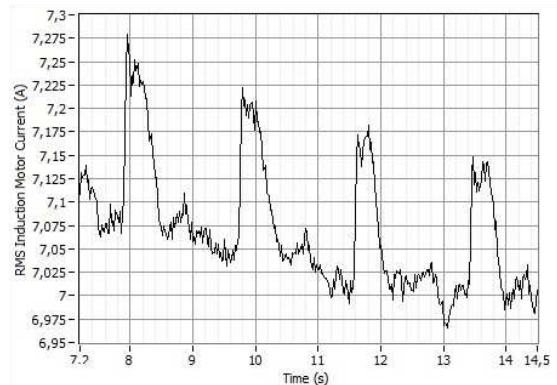
Fig.6: The induction motor current was measured at 1400 RPM.

When the induction motor runs at high speed the gears become well lubricated and the motor current increases just when the damaged wheel teeth area reaches the worm, corresponding to an extra mechanical torque demand. The general motor current decrease is due to a lubrication increase, diminishing friction between gears.

- At high speed the motor current increased each 1.8 seconds (Fig. 6)
- At low speed the motor current decreased each 7.4 seconds Fig. 7).

As the time that the friction wheel takes for a full revolution is 1.8 seconds at high speed and 7.4 at low speed, it makes us believe that these current signatures could be related to some mechanical fault in the reducer.

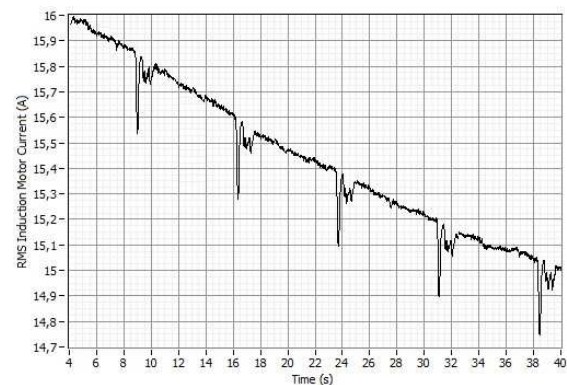
Fig. 7: The induction motor current was measured at 310 RPM.

At slow speeds the torque is affected by static friction and by the lack of lubricants that stay immobilized at the bottom of the worm wheel. In fact, when the worm wheel was turned slowly

by hand, it can be noticed a hard friction during certain rotational angles, confirming the plot presented in Fig. 7.

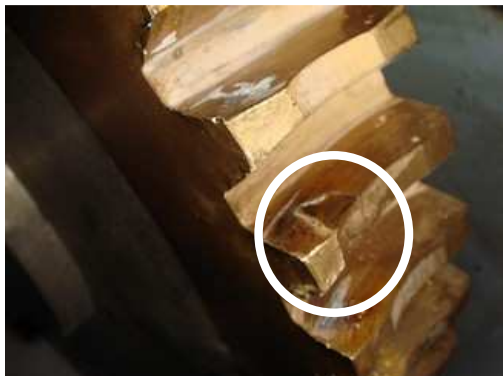
The reducer was disassembled and some damaged teeth were found in the worm wheel (Fig. 8). This kind of damage could be caused by incorrect handling during assembly operations.

Fig. 8: Detail of a worm wheel showing tooth damage.

After fixing the above referred mechanical faults in the reducer worm wheel, the induction motor current plot was smoothed without the spikes as shown in the previous tests.
