On-site Assessment of High Voltage Motors Insulation Operating in Oil Facilities

Abstract. Thirteen motors rated at 13,8 kV and 2500 H. P. of capacity installed and operating in a critical Oil Pumping Plant, were evaluated on-site, to determine the insulation system condition and schedule a maintenance program. This on-site assessment was based on a non-invasive and non standardized ultra-wide band partial discharge technique developed. The results obtained allowed motors insulation system status classification, according to partial discharges measured on ground connection of the main cables of the motor, employing near field sensors. A traditional N-Q-Φ Partial Discharge pattern is obtained to facilitate motor insulation system problems identification. The results of this on-site motor assessment, during normal operation, and its application on maintenance programs are presented and discussed in the paper.

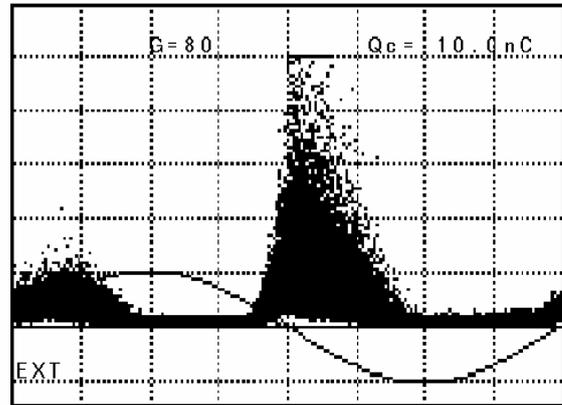
Fig. 2. Motor M-14 PD pattern, 570 nC Max.

The PD pattern shown in Figure 2, shows the PD activity map obtained in phase 3 of motor M-14. It distinguishes that PD in the negative semi cycle are greater than those of positive in 5:1 relationship. This pattern and the high

level of DP (570 nC) according to [5], is typical of the activity of slot partial discharges (PD between coil surface and stator core laminations). This mechanism of deterioration is the most severe, from the electrical insulation point of view.

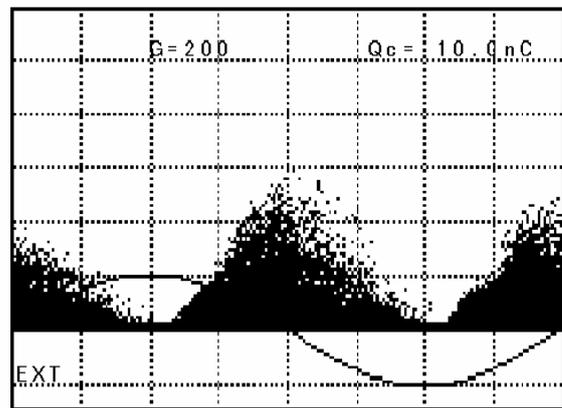
Fig. 3. Motor M-13 PD pattern 120 nC

The Figure 3, shows the pattern of the PD activity map obtained in phase 2 of motor M-13. The partial discharges have similar magnitudes in both semi cycles. The pollution deposited in the end windings can be the PD cause; the pollution avoids the correct graduation of electric field. Another cause may be the deterioration or incorrect stress grading coating application.
